METEOROID AND DEBRIS IMPACT FEATURES DOCUMENTED ON THE LONG DURATION EXPOSURE FACILITY

A Preliminary Report

Compiled by Members
of the LDEF Meteoroid
and Debris Special
Investigation Group

Space & Life Sciences Directorate
Solar System Exploration Division
Planetary Science Branch
Publication # 84
JSC # 24608

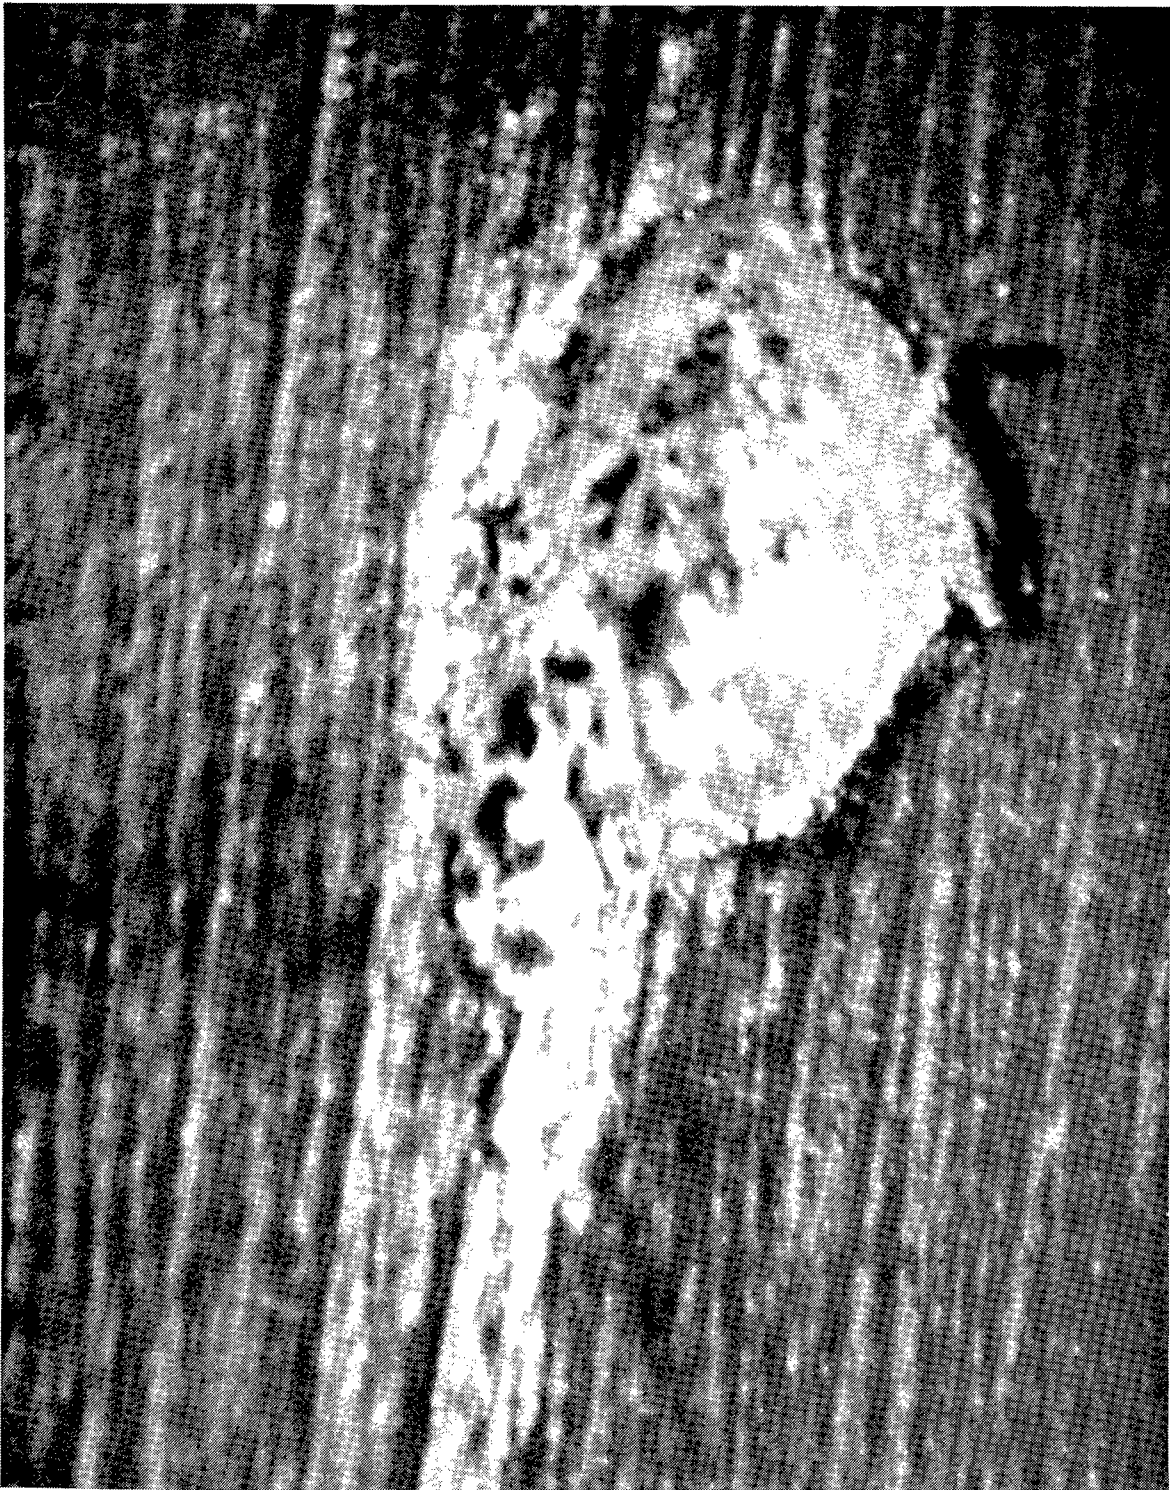
Figure 5. Photograph of an elongate feature in an aluminum surface, probably from an extremely low-angle ($<5^\circ$) or oblique impact. View measures approximately 1.5 cm across.

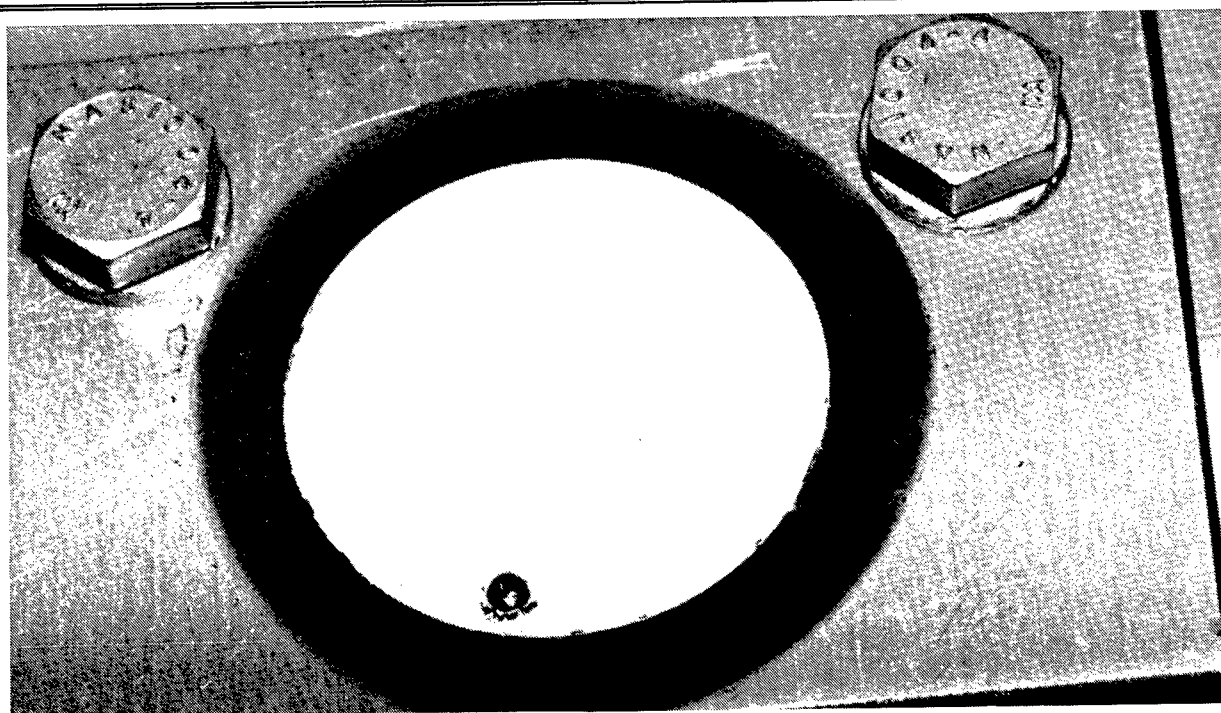
Figure 9. Impact into one of the paint specimens on an experiment-tray clamp. This particular feature was the largest impact feature found on the numerous tray clamps. View measures approximately ~6.5 cm across.

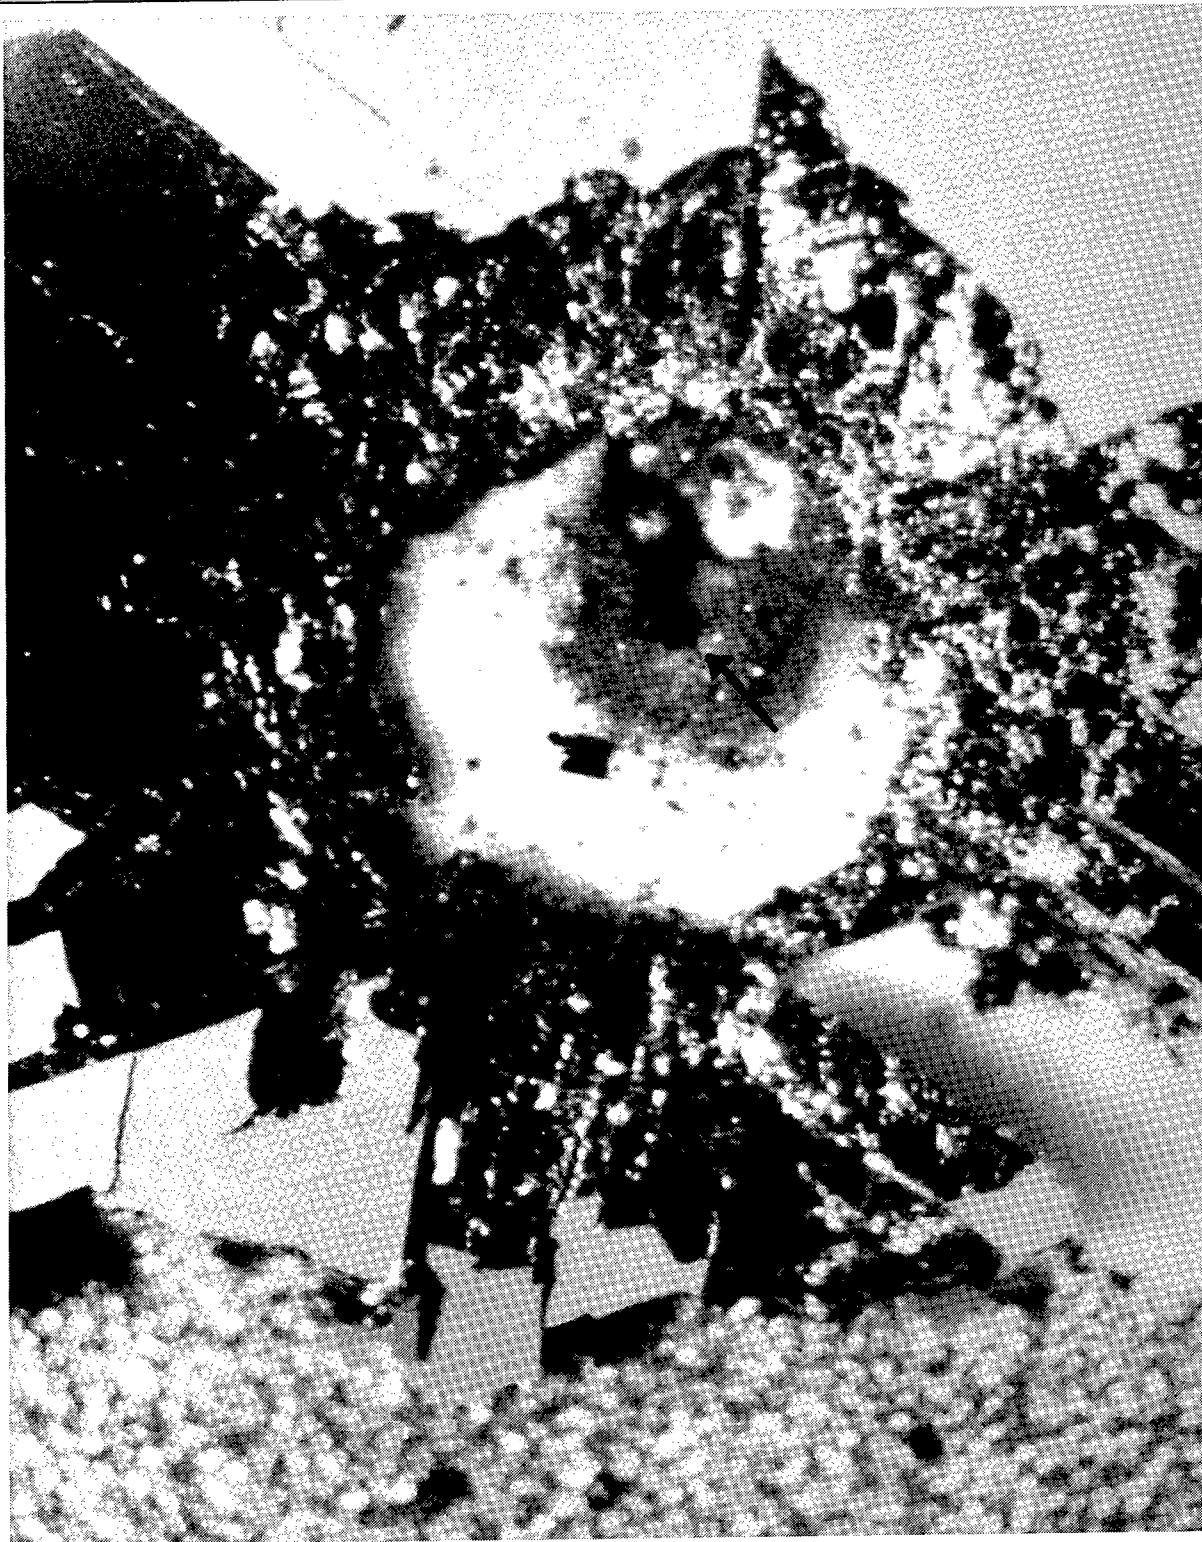
Figure 11. Photograph of an impact feature in one of the metal-oxide-silicon (MOS) detectors of the Interplanetary Dust Experiment (A0201; Bay B12). A central penetration hole (arrowed) is surrounded by a crater and extended fracture zone. View measures approximately 1 mm across. The same feature at a lower magnification can be seen in Figure B12-2.

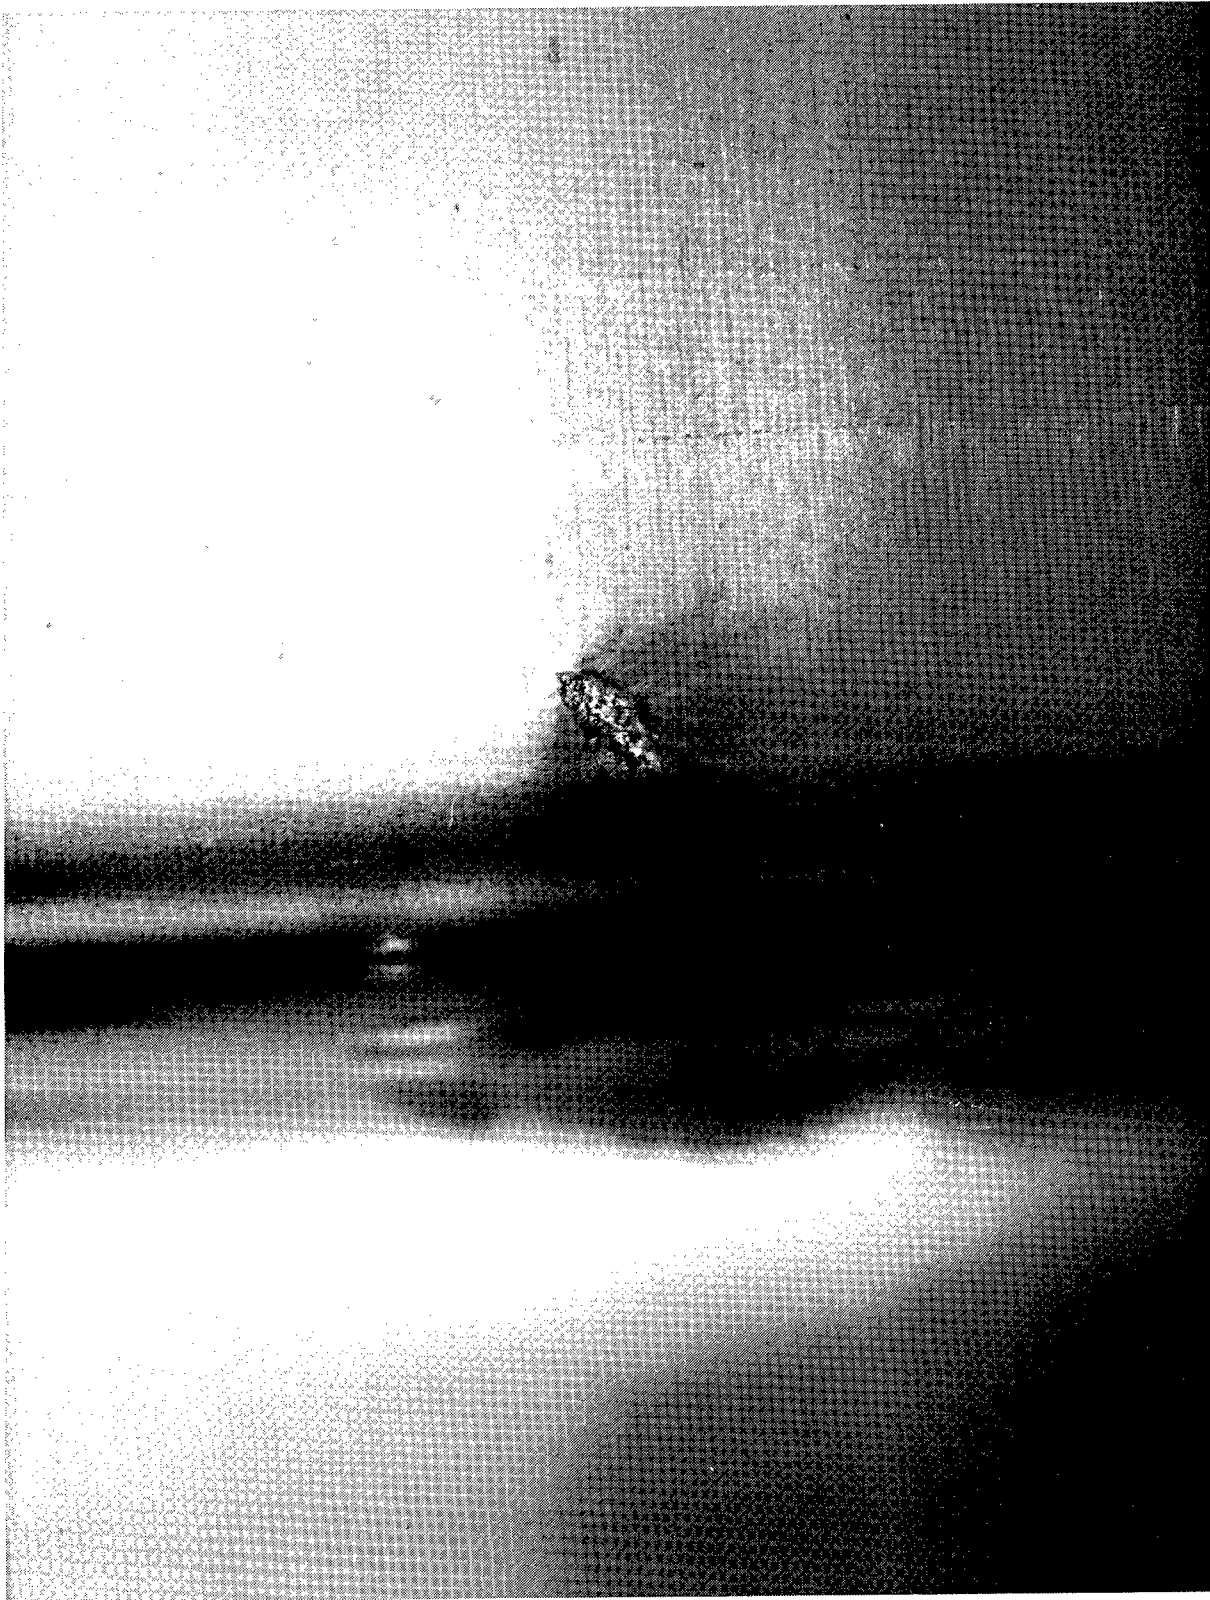
Figure 14. Photograph of an oblique feature on the experiment-tray flange of an A0178 tray. The complex inner morphology of this feature may indicate that it is the result of a multiple-impact event, or an impact from a poorly indurated particle. Note presence of associated (red) debris surrounding the impact site.

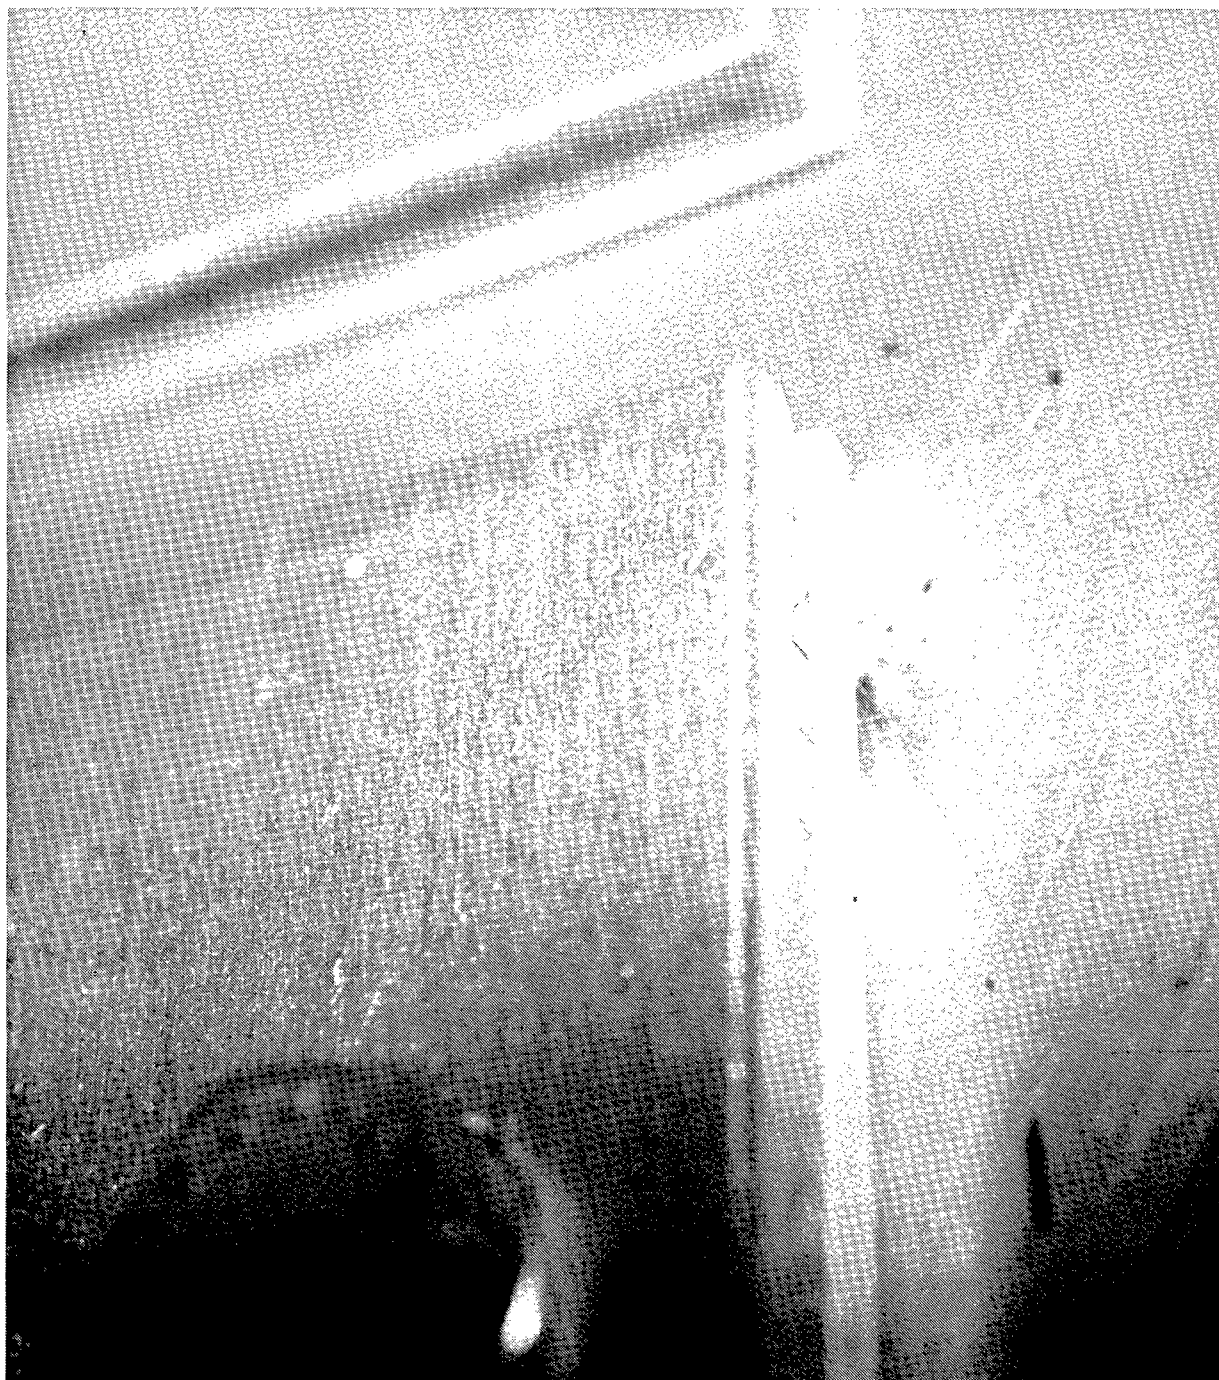
Figure 17. Impact (and associated debris) into the edge of a clamp shim. Features such as these which could be damaged or destroyed during the deintegration of the experiment trays from LDEF were one of the primary reasons for conducting the pre-deintegration survey.
